# Manhole Inspection Summary

Manhole # S15C1\_008MH

Insp Date: **5/27/08 1:39 PM**

**Location** Address: **2913 georgetown-herkimer alley** Cross Street: **foresthill-inverness alley**

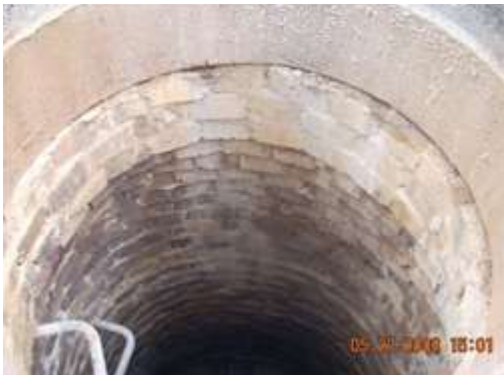
Miscellaneous

**Manhole** Type: **Junction** Location: **Alley** Ground Conditions: **Dry**  
☐ Prev. Rehab Weather: **Dry** Subject To Ponding: **Sheeting**

inflow evidence from sheeting

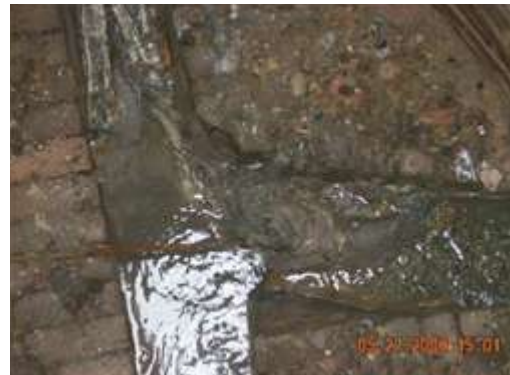
Defect 2

Condition: ☐ Sound ☐ Cracked ☐ Root Intrusion ☐ Deteriorated ☐ Leaks ☒ **Debris**

debris in channel and on bench

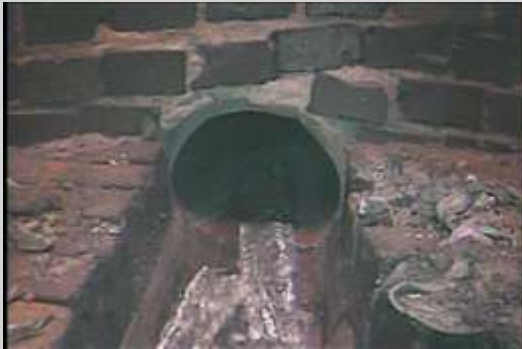
12 O'Clock Outflow

Deposits: ☐ None ☐ Mud ☒ ~~Sludge~~ ☒ Debris ☐ Grease

Silt Depth: **2** (in.) Deposits Extent: **Light**

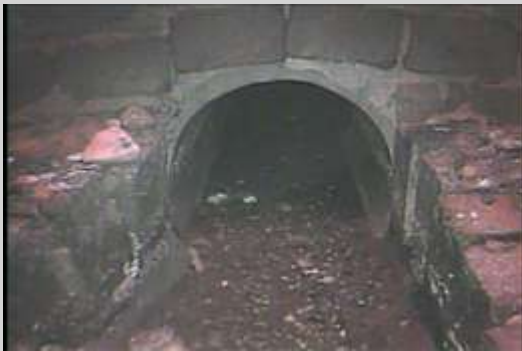
3 O'Clock Inflow

Deposits: ☐ None ☒ Mud ☒ ~~Sludge~~ ☒ Debris ☐ Grease

Silt Depth: **3** (in.) Deposits Extent: **Medium**

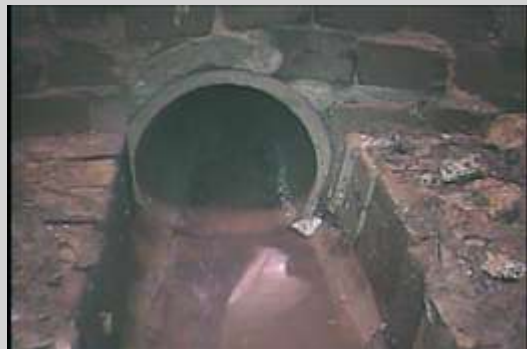
6 O'Clock Inflow

Deposits: ☐ None ☐ Mud ☒ **Sludge** ☐ Debris ☐ Grease

Silt Depth: **1** (in.) Deposits Extent: **Light**
